# The Maintenance of Pontcysyllte Aqueduct

Stephen Priestley

*The date of this Journal coincides with the 200th anniversary of the opening of Pontcysyllte Aqueduct. The story of its design and construction is well-known, but its history did not stop there: the story of its maintenance is also of interest.*

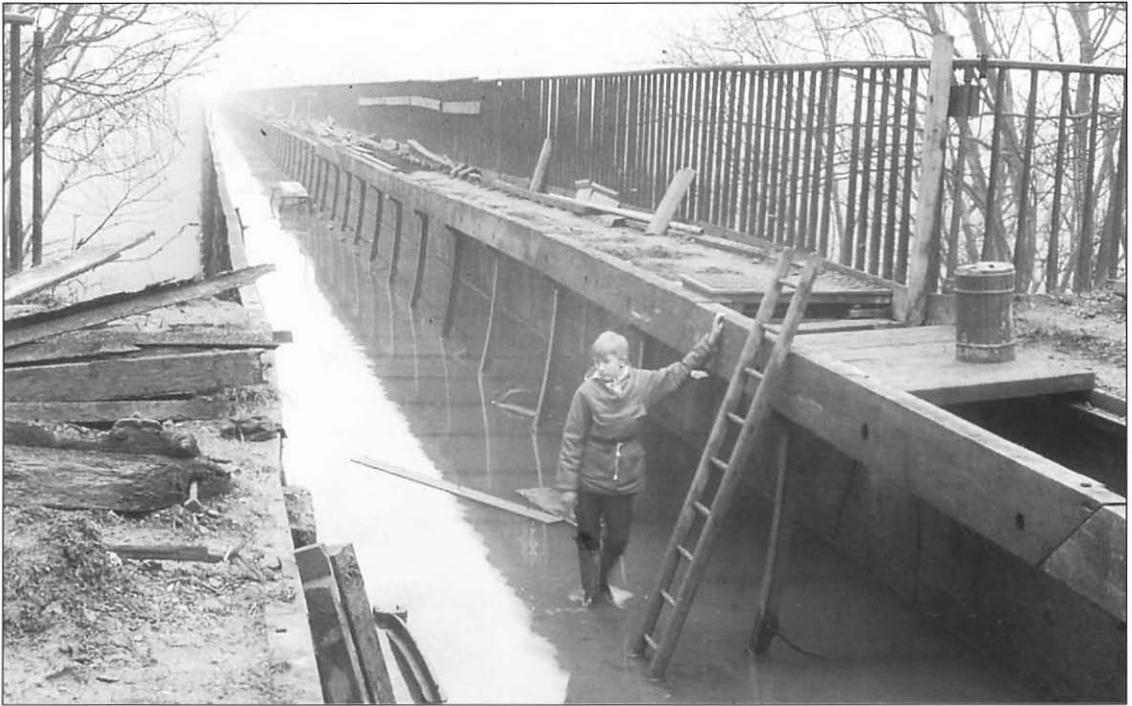
*Pontcysyllte Aqueduct drained for maintenance in 1964  
(RCHS: Weaver Collection)*
